Slipline Methodology Rehabilitates Large-Diameter Water Main

Because of increasing leaks in a water main and costly repairs, a Virgin Islands utility turned to slipline technology to rehabilitate the main, minimize commercial disruptions during the rehabilitation, and mitigate corrosion. **MUSTAFA ABUSAOUD AND RICHARD BOTTEICHER**

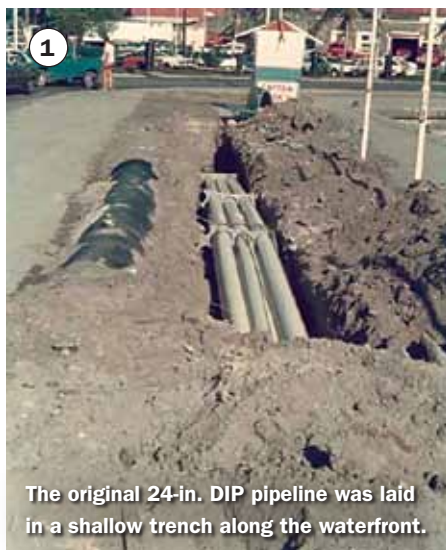
1 The original 24-in. DIP pipeline was laid in a shallow trench along the waterfront.

The 24-in. DIP pipeline had been installed in a shallow trench along the waterfront apron and capped with concrete, which served as the apron next to the roadway and between the roadway and waterfront. The area, composed mainly of fill materials, was created when the harbor had been improved (Photograph 1).

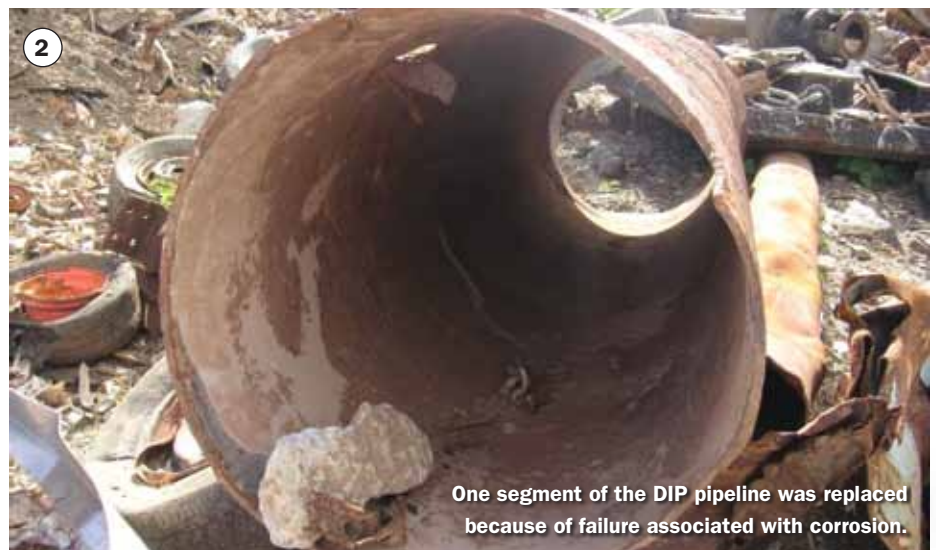
2 One segment of the DIP pipeline was replaced because of failure associated with corrosion.

Over the years, various problems with the 24-in. DIP pipeline arose, particularly those caused by pipeline corrosion resulting from exposure to harbor-influenced groundwater below the concrete pavement (Photograph 2). The pipe sits above the surface in three locations to accommodate conflicts with other utility lines and the shallow nature of the pipeline (Photograph 3). These locations enable personnel to easily observe and assess

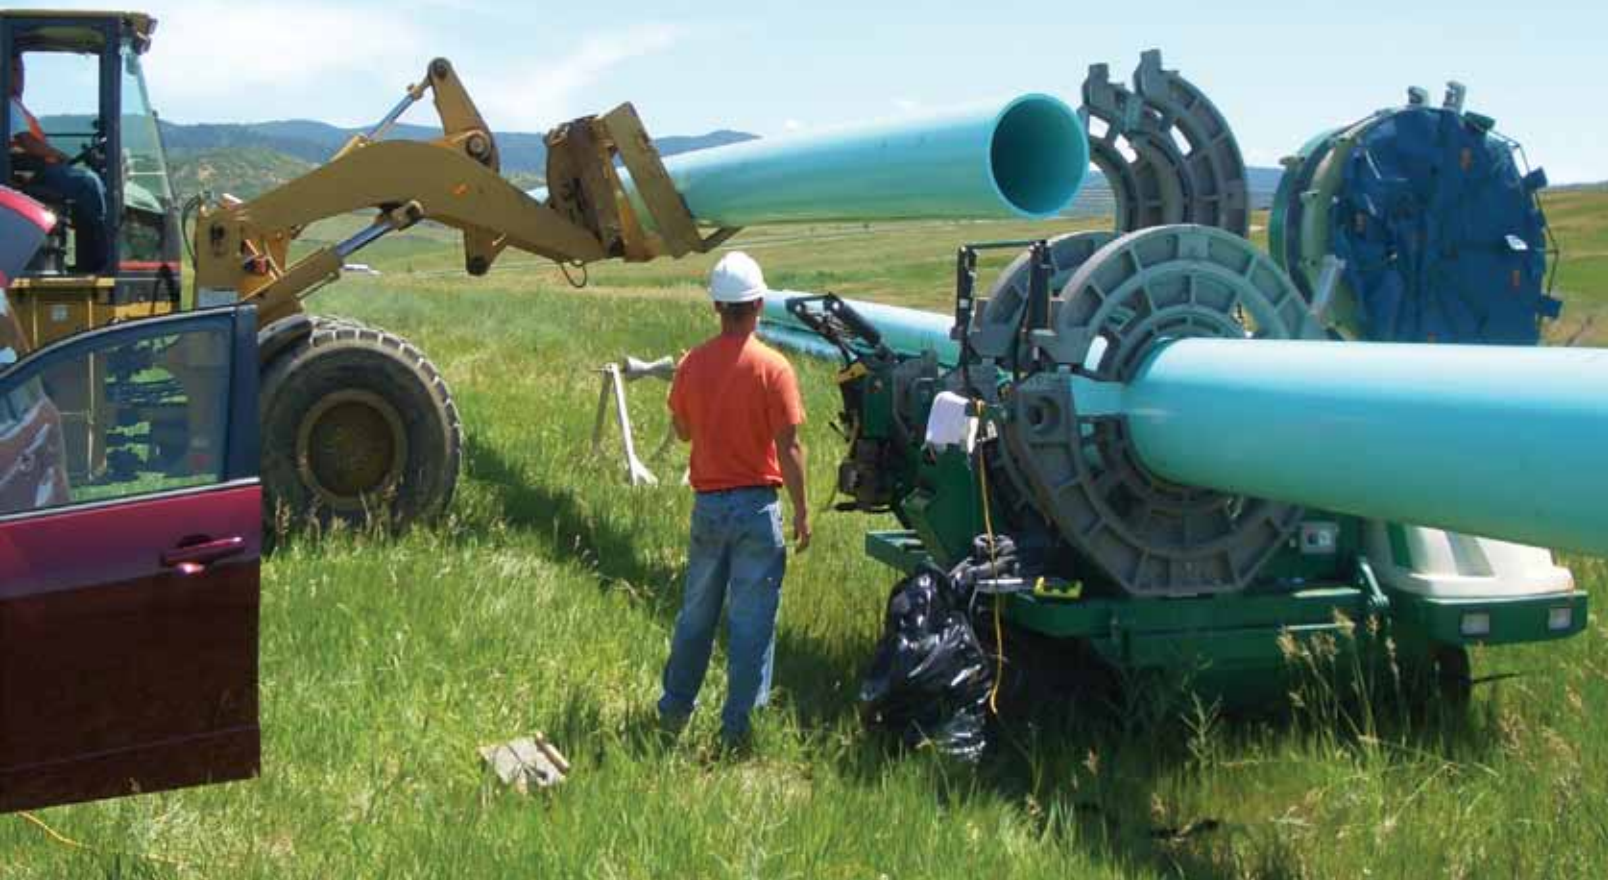
FPVCP was loaded into a typical fusion machine to be joined.

FPVCP uses a thermally fused or bonded connection instead of a mechanical and/or gasketed connection like other PVC pipe-joining technology used today. Two plain-end lengths of FPVCP are joined by heating the ends of the pipes until a fusible bead of material is formed on each, and then the pipe ends are brought together and held under pressure until they cool to ambient temperature.
