MUNICIPAL

DOUBLING UP

The City of Billings uses pipe bursting with in-house crews to repair water distribution leaks and enlarge mains to ensure adequate flow for fire protection

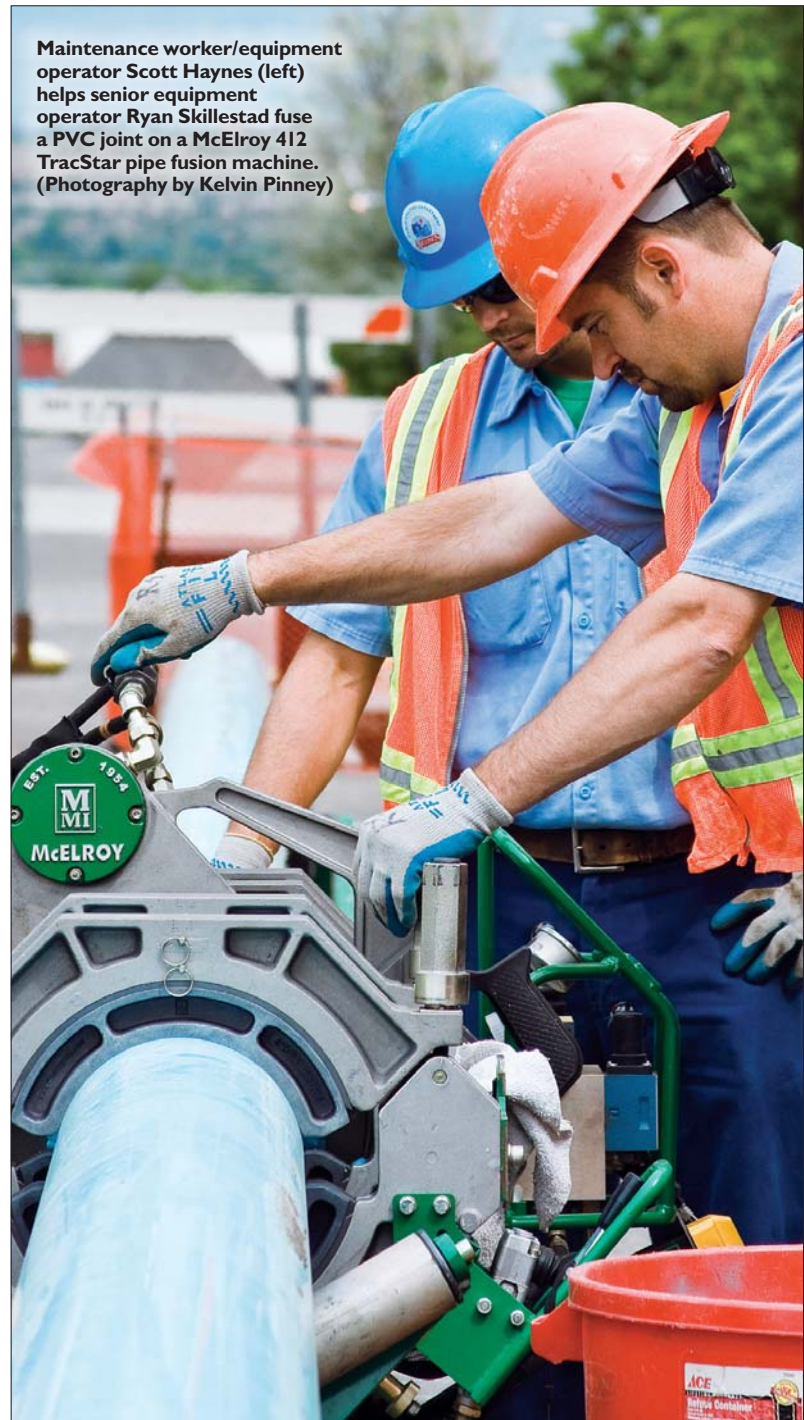
Maintenance worker/equipment operator Scott Haynes (left) helps senior equipment operator Ryan Skillestad fuse a PVC joint on a McElroy 412 TracStar pipe fusion machine. (Photography by Kelvin Pinney)

Ten-foot lengths of 8-inch PVC pipe are heat-fused into a permanent butt joint with the McElroy 412 fusing machine at street level. The machine incorporates a hydraulic pipe lift to assist in loading and unloading and is mounted on tracks for easy maneuvering at the job site.

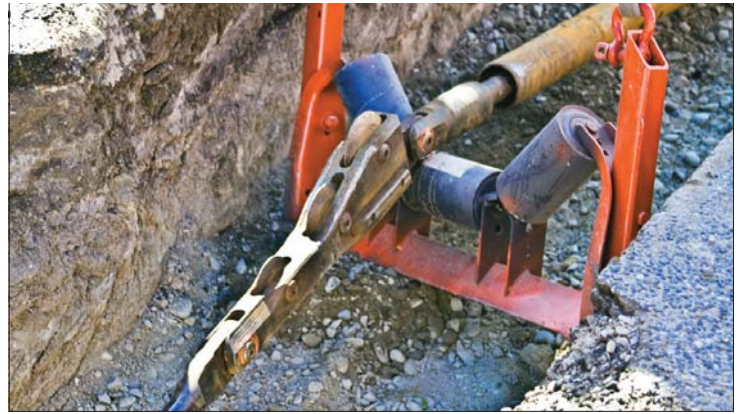
Scott Haynes (left) and Ryan Skillstad work with the fusion machine as part of the fusible PVC pipe replacement system offered by Underground Solutions.

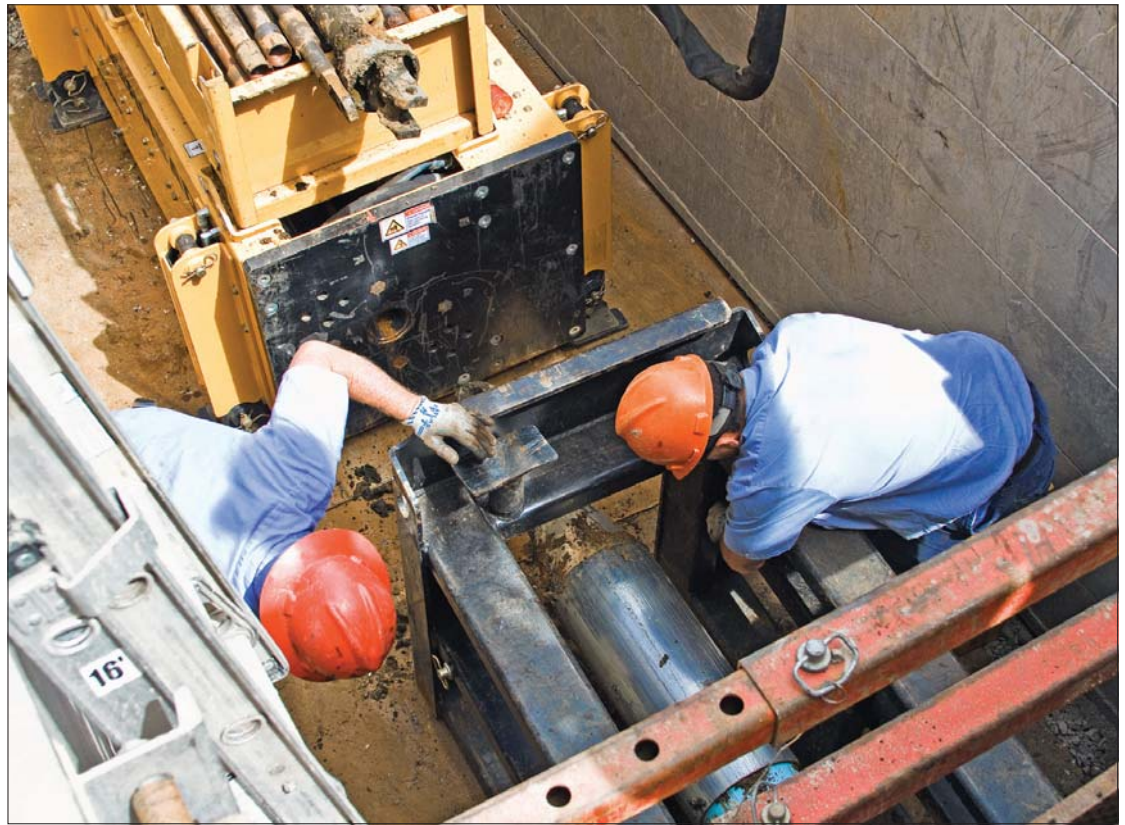
Senior equipment operator J.R. Fox (right) and maintenance worker/equipment operator Jim Burchell operate the HammerHead 100-ton hydraulic pulling unit.

Next, the crew feeds 3-foot rod sections through the host pipe into the entry pit. The tooling and the conical-shaped HammerHead pull head are attached, and then the whole assembly, including the trailing PVC pipe, is pulled through to the next intersection. A slitter splits the host pipe, and the conical bursting head follows, breaking the pipe apart and pushing the debris into the surrounding soil.

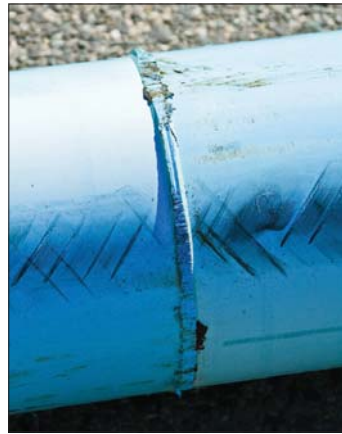
A finished fused joint between two sections of fusible PVC pipe.

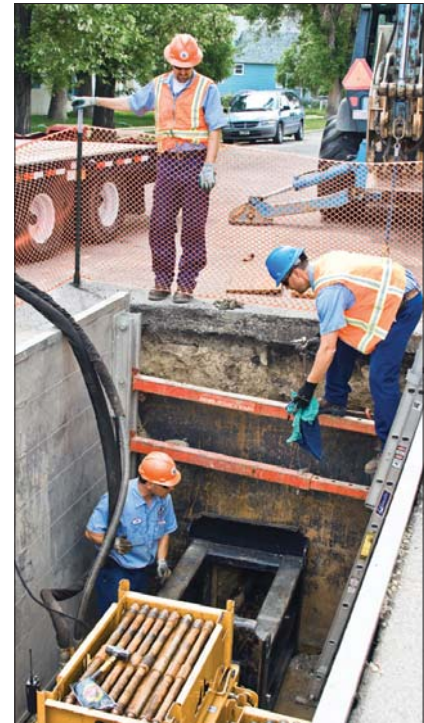
J.R. Fox (in excavation) realigns the HammerHead pulling unit while Scott Haynes (right) and Ryan Skillestad assist.
